Routes 7/15 Interchange  
Norwalk, Connecticut  
State Project 102-358

Analysis, Needs, and Deficiencies  
Report

Prepared for:  
CTDOT

Prepared by:  
Stantec Consulting Services, Inc.

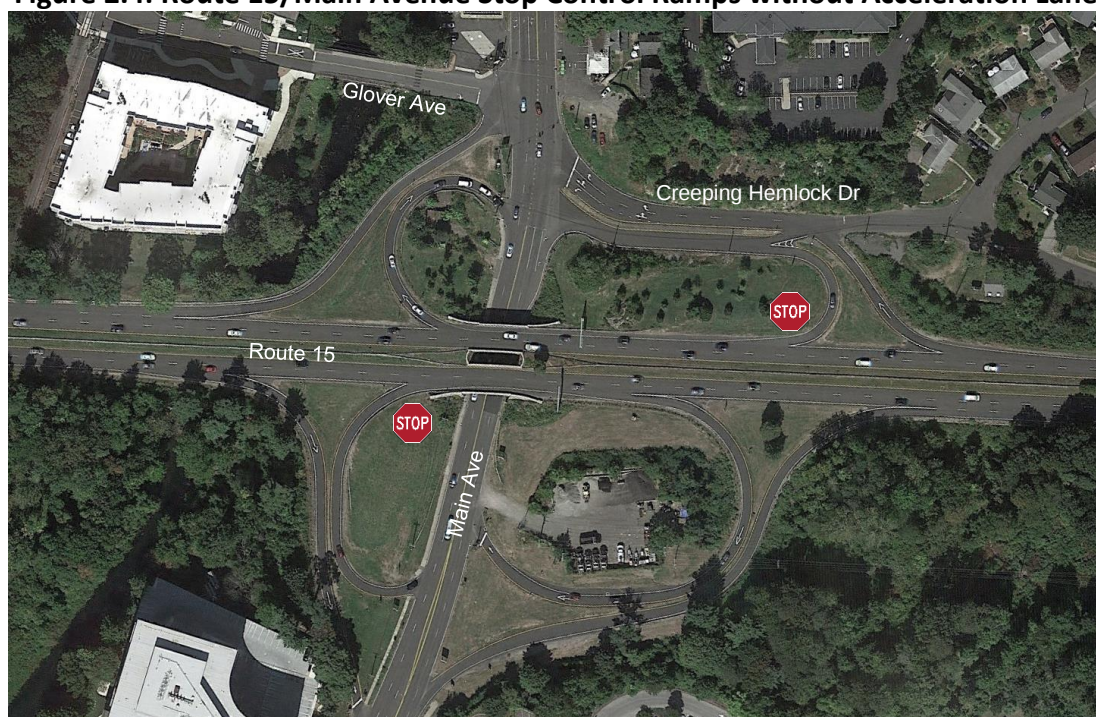
**Figure 2.4: Route 15/Main Avenue Stop Control Ramps without Acceleration Lanes**

Interchange No. 40 is located approximately 1,500 feet east of the Route 7 and Route 15 interchange and provides connections in all directions between Route 15 and Main Avenue. Two of the Route 15 on-ramps at this interchange are stop-controlled and have no acceleration lanes; Main Avenue southbound to Route 15 northbound; and Main Avenue northbound (via Creeping Hemlock Drive) to Route 15 southbound as noted in Figure 2.4 below.

Although this interchange generally resembles a typical cloverleaf interchange, its proximity to the Main Avenue intersection with Glover Avenue and Creeping Hemlock Drive results in several unusual ramp movements (particularly for traffic entering and exiting Route 15 southbound). In both directions on Route 15, Exit 40A is intended for vehicles heading southbound on Main Avenue, and Exit 40B is intended for vehicles going northbound on Main Avenue. However, Exit 40B southbound directs traffic onto Creeping Hemlock Drive which then permits vehicles to turn left toward Main Avenue southbound at the signalized intersection. Vehicles have been observed to follow this circuitous route rather than using Exit 40A southbound due to the tight loop off-ramp immediately west of Main Avenue.

Northbound traffic on Main Avenue is directed to turn right onto Creeping Hemlock Drive to access Route 15 southbound via a STOP controlled on-ramp. Instead, some northbound vehicles turn left at the signalized intersection onto the Route 15 southbound on-ramp near Glover Avenue (which is not STOP controlled). Similarly, even though southbound traffic on Main Avenue is directed to turn right at the Glover Avenue intersection for access to Route 15, vehicles are also permitted to turn left toward the Route 15 southbound on-ramp (via Creeping Hemlock Drive).

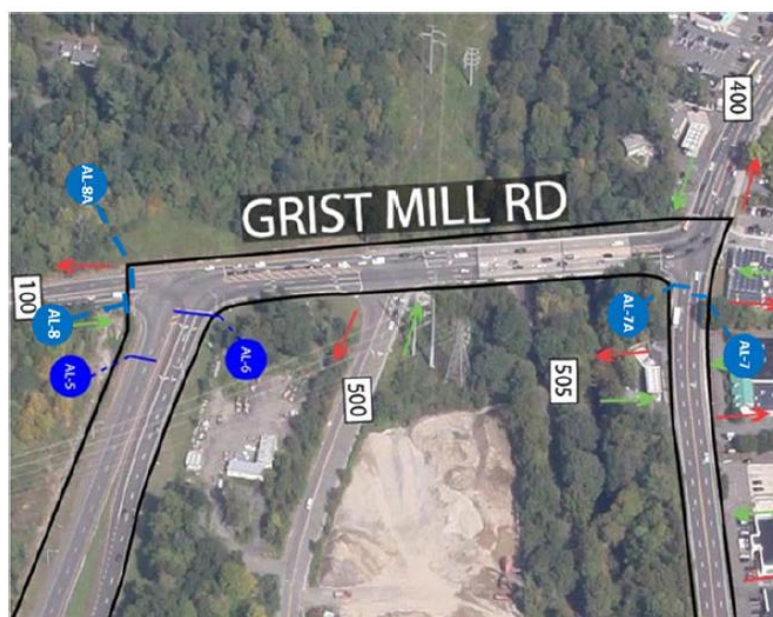
**Figure 3.27: Skycomp O-D Study AL's – Route 7 at Grist Mill Road and Main Avenue**

The origin and destination points of all vehicles were tracked at eight specific points, or “assignment lines”, through the study area roadway network and surrounding the partial Route 7/Route 15 interchange and the associated missing movements as shown previously in Figure 2.3. A sample number of vehicles were selected at eight locations, or “assignment lines” across main roadways at the north, south, and east ends of the survey area and were traced backward to their origins and/or forward to their destinations. Figure 3.27 through Figure 3.29 shows the assignment lines (AL) which were traced.

The vehicles crossing these lines are traced to origins and destinations marked by the white boxes. Vehicles were traced as needed until leaving (or entering) the survey area across a black boundary line. A sample rate at each AL was selected to produce a sample size of 10% of 90 minutes of flow, or 150 vehicles, whichever was larger, for each AL for each peak period. The sample size was selected in coordination with Skycomp and represents a threshold where the sampled data is statistically significant enough to discern travel patterns. In order to produce reliable tracing results, Skycomp used proprietary software to perform computer-assisted manual tracing from the aligned aerial imagery.

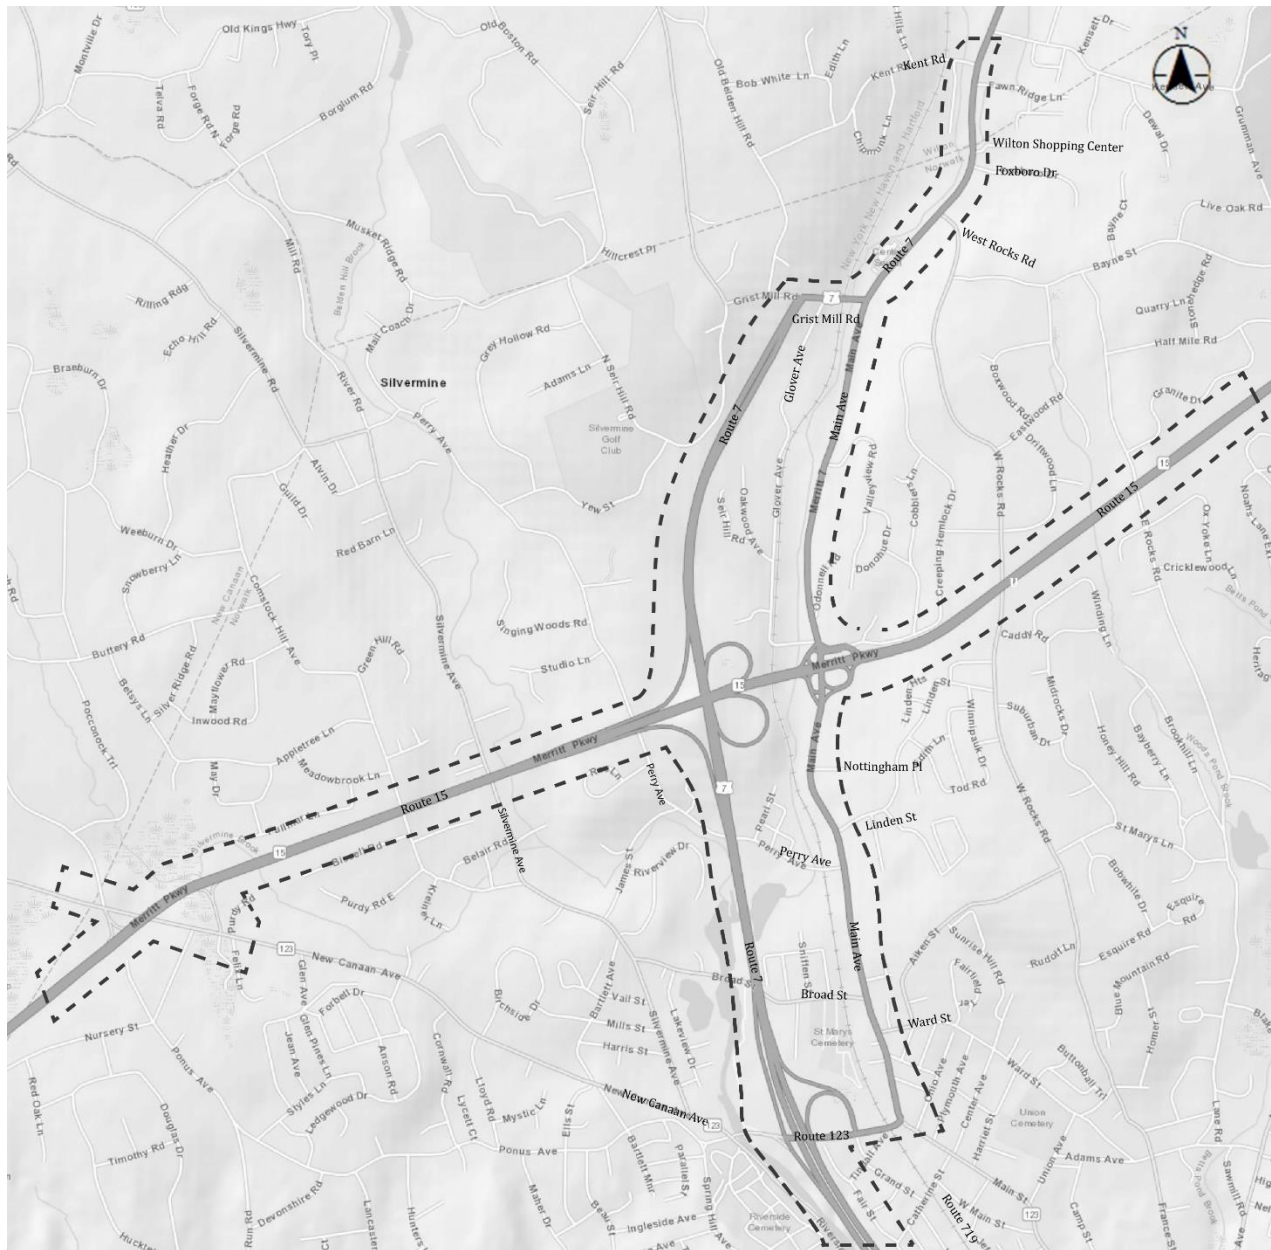
**Figure 5.1: VISSIM Simulation Model Roadway Network**

In the case of the Route 7/15 micro-simulation model, the network includes Main Avenue, Grist Mill Road, Glover Avenue, Route 7, Route 15, and Route 123. The boundaries are Grist Mill Road to the north, Route 123 to the south, the West Rocks Road Bridge over Route 15 to the east, and Route 123 at the Route 15 interchange to the west. Figure 5.1 shows the extents of the simulation model network.

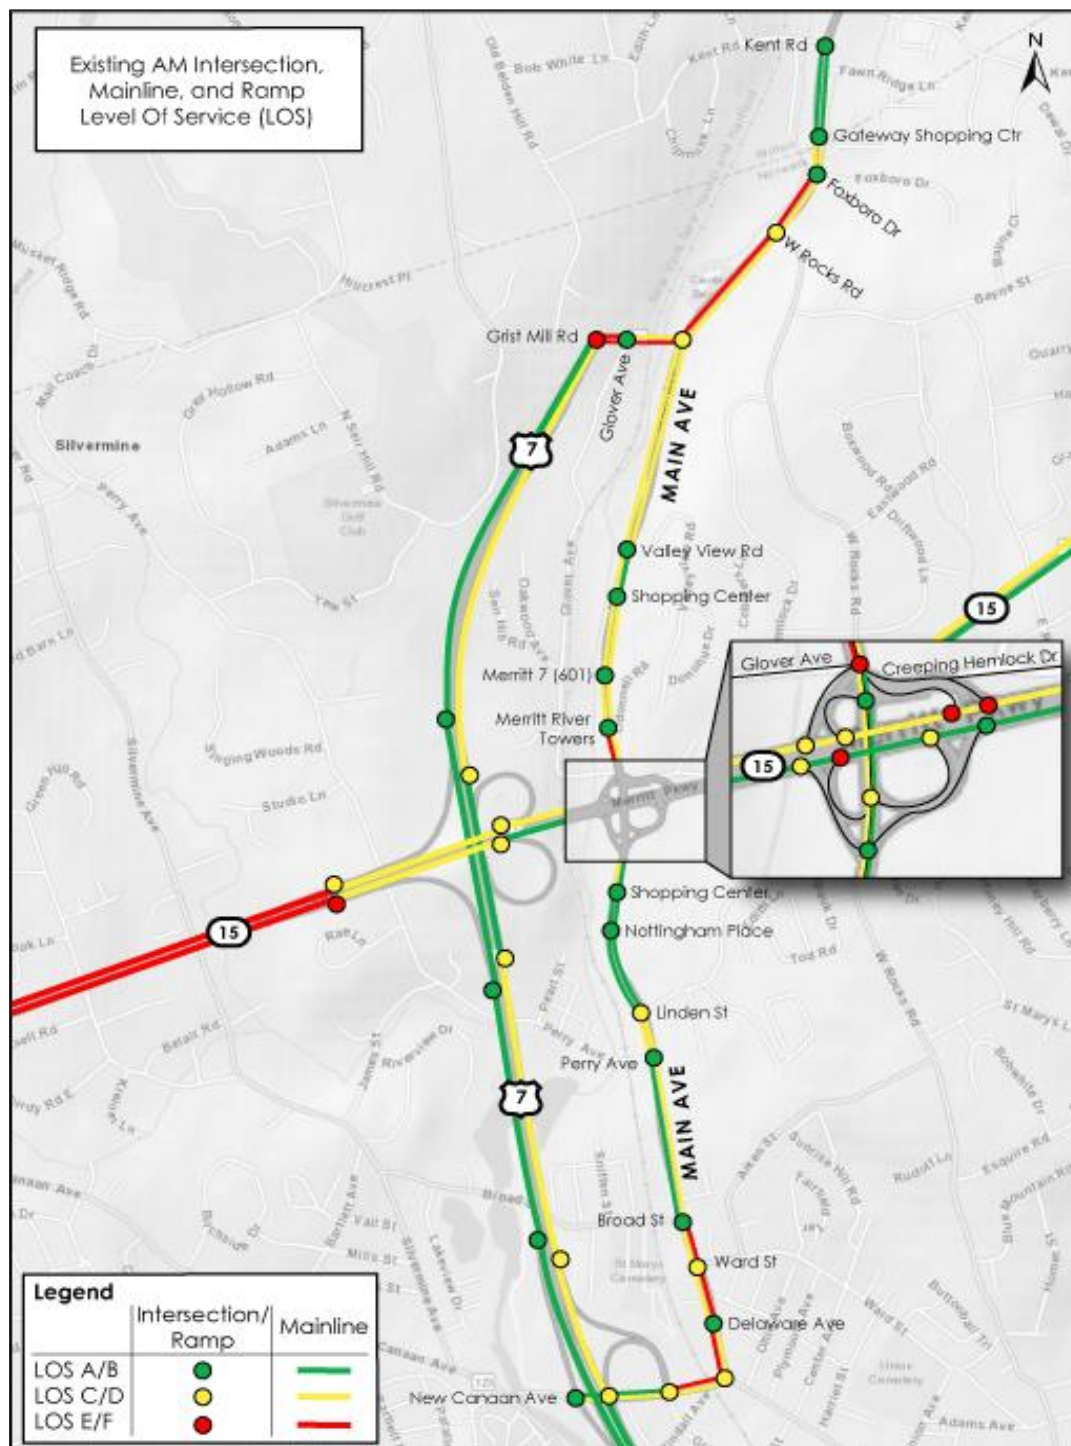
**Figure 5.2: Intersection, Mainline, and Ramp LOS Summary – Weekday AM Peak Hour**

Figure 5.2 and Figure 5.3 illustrate a holistic view of LOS throughout study area corridors, including intersections, ramps, and along mainlines for the weekday AM and weekday PM peak hours, respectively.
