Routes 7/15 Interchange Norwalk, Connecticut State Project No. 102-358

Environmental Assessment,
Draft Section 4(F) Evaluation and
Environmental Impact Evaluation

Appendix G Wetland Assessment

Appendix G1 2017 Wetland Report

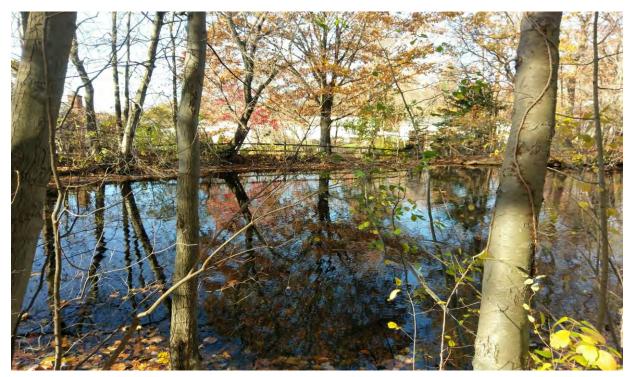
Pond 1 is located north of Creeping Hemlock Drive and West of Lakewood Drive. The pond is long and linear, orientated roughly north to south; and is surrounded by forested upland. The water is estimated to be three to four feet deep, and no substrate was visible at the time of the investigation. Water was noted flowing through a stone swale on the western side of the pond. The swale is located outside of the project limits and continues to the west, north of several residential homes.

PHOTO 1: View of Pond 1, looking northwest.

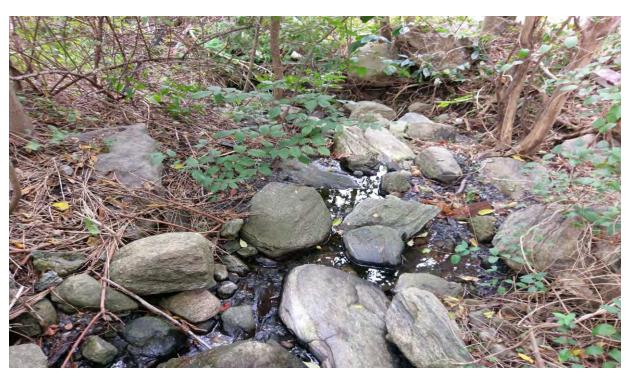
Perennial watercourse 1 is located north of Route 15 and south of Creeping Hemlock Drive. The watercourse originates at a 24" reinforced concrete pipe (RCP) in a masonry endwall along the Route 15 southbound embankment. The substrate in the vicinity of the outfall includes rocks, cobble, and gravel, as well as some bricks that appear to have deteriorated from the end wall. The channel becomes narrow, approximately 2 feet wide, and very steep with rock and cobble substrate as flows progress to the west. At the base of the steep slope, the water forms a large pool and receives hydraulic input from a 15" RCP which is partially buried and a 48" RCP that conveys flows from north of Creeping Hemlock Drive. The pool is approximately 7 feet wide, with a rock, cobble, gravel, and sand substrate. Sediment deposition in this area is notable. Further west, the watercourse enters a 48" x 48" box culvert at a skew angle which conveys the flows southerly under Route 15 and outlets into Wetland 1. Vegetation is present along the channel, and includes Norway maple (Acer platanoides), winged euonymus (Euonymus alatus), multiflora rose (Rosa multiflora), wineberry (Rubus phoenicolasius), beggar tick (Bidens frondosa), jewelweed (Impatiens capensis), and aster (Symphyotrichum sp.). Additionally, a masonry rock wall is present along the north edge of the channel for the majority of its length.

PHOTO 2: View of upper reach of PER 1 near the pipe outfall, looking west.

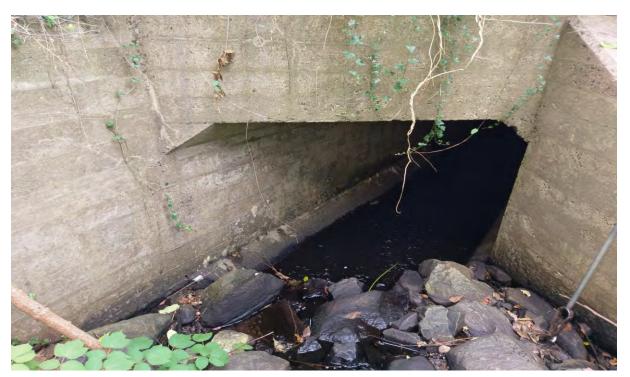
The box culvert conveys this watercourse under Route 15 and outlets into Wetland 1 where the flow becomes diffused through the wetland, and the channel loses its definition. Wetland 1 is described in more detail separately below. At the southern portion of the wetland, the channel becomes more well defined with areas of incised banks, approximately one-foot-high and 3 feet wide. Deep pools were observed in portions of the channel, and a small oxbow was also noted along the embankment to the Stop and Shop shopping center to the south. The watercourse then flows west where the channel widens to approximately 10 feet with a silt and gravel bottom.

PHOTO 3: View of PER 1 box culver inlet north of Route 15 southbound.

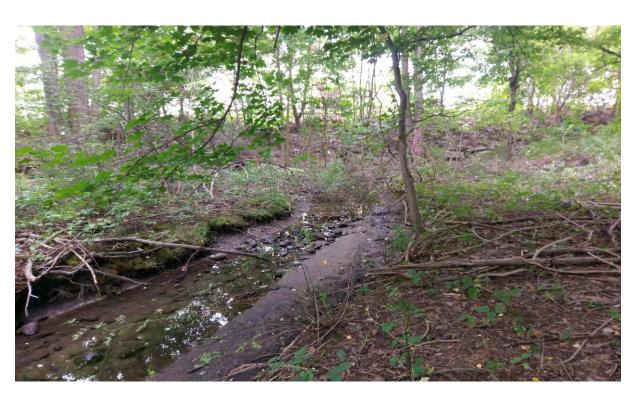
PHOTO 4: View of PER 1 south of Route 15 northbound, looking south towards parking lot.

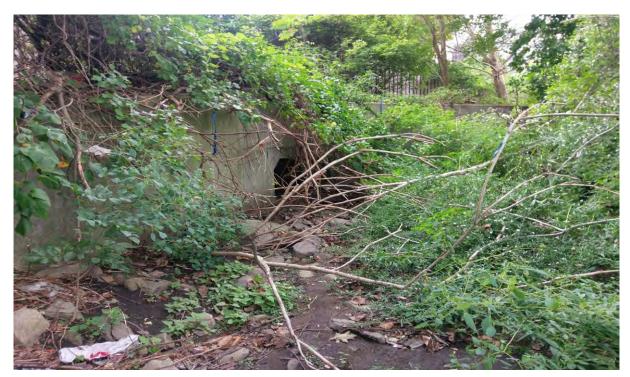
PHOTO 5: View of PER 1, after it transitions to intermittent at culvert inlet near Main Ave, looking southeast towards the parking lot.

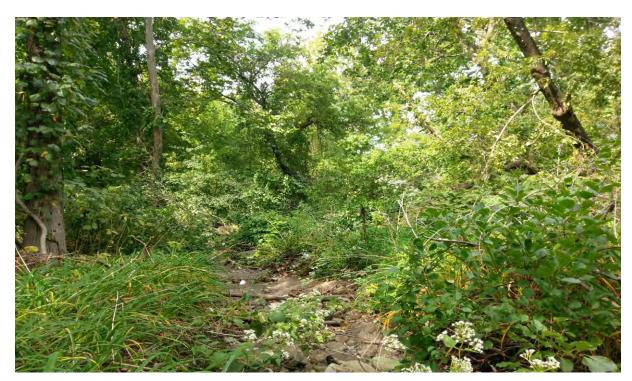
Intermittent Watercourse 1 is located west of the Route 15 off-ramp to Route 7, and south of Route 15. The watercourse originates at a 30" RCP that conveys drainage from Route 7 and surrounding uplands, and flows into west into Wetland 2 where the channel loses definition. The substrate in the vicinity of the outfall includes large rock piles, cobble, gravel, sand, and wood chips. The channel is incised near the pipe outfall and blocked by several downed trees and litter from the nearby off-ramp. Sediment deposits are extensive throughout the channel, with large piles of sand noted in portions of the channel and nearby Wetland 2. The channel is approximately 3 feet wide throughout. Vegetation along the channel includes jewelweed (*I. capensis*), white snakeroot (*Ageratina altissima*), mugwort (*Artemisia vulgaris*), and oriental bittersweet (*Celastrus orbiculatus*).

appears to retain flows during storm events. The dense herbaceous stratum provides sediment trapping. Sedimentation was noted through the intermittent watercourse (INT 1) that flows through Wetland 2. The dense herbaceous vegetation present in Wetland 2 aids in the removal, retention, and transformation of nutrients. Additionally, dense vegetation borders the river and provides shoreline stabilization. The wetland also provides a small patch of habitat for animals tolerant of the surrounding development.

PHOTO 7: View of INT 1 through Wetland 2, looking northwest towards the Norwalk River.

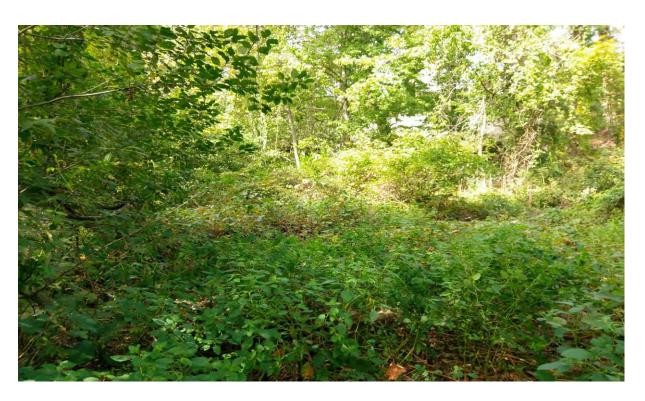
PHOTO 8: View of Wetland 2 looking north towards Route 15.

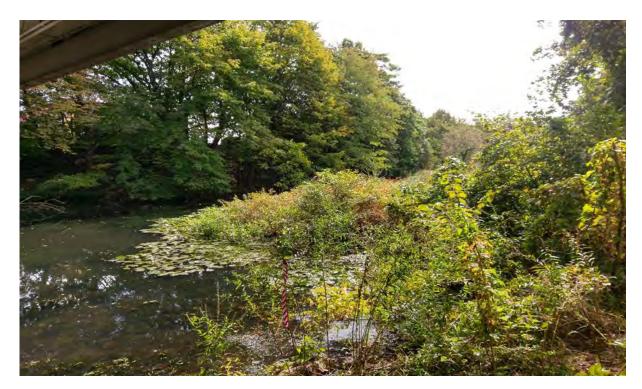
Wetland 3 is located south of Route 15, east of the Norwalk River, west of Main Avenue, and south of Wetland 2, and lies entirely within the mapped FEMA floodway for the Norwalk River. The wetland is divided into two sections that appear to be peninsulas formed by the periodic backwater of the Norwalk River. The southern section is situated at the base of a steeply sloped hill and extends into the river where a narrow channel caused by backwater from the river has dissected it from the northern portion of the wetland. The northern portion of the wetland is situated in a fairly level area, with water from the Norwalk River present to the east and west. The vegetation on both sections of the wetland appeared to be very similar, and therefore were categorized as the same wetland community. This palustrine scrub-shrub wetland is characterized by saturation at 12 inches, drift deposits, water-stained leaves, drainage patterns, and geomorphic position. Sparse tree canopy is composed of green ash (F. pennsylvanica), and a dense scrub-shrub stratum is dominated almost entirely by silky dogwood (C. amomum). The herbaceous stratum is dominated by jewelweed (I. capensis), with sensitive fern (O. sensibilis) and Virginia creeper (Parthenocissus quinquefolia) also present in the herb layer.

PHOTO 9: View of Wetland 3 looking south, note backwater channel from the Norwalk River.

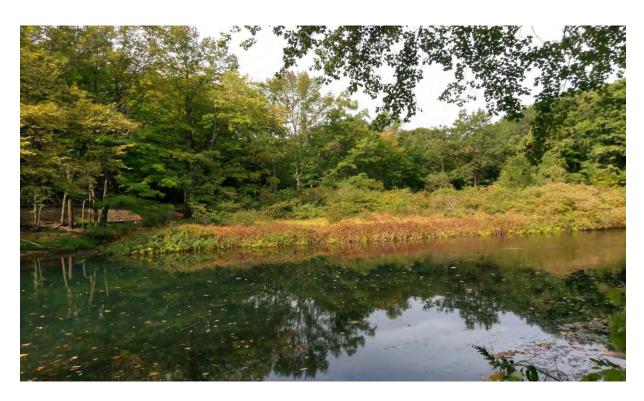
PHOTO 10: View of Wetland 4 from the east bank of the Norwalk River looking northwest.

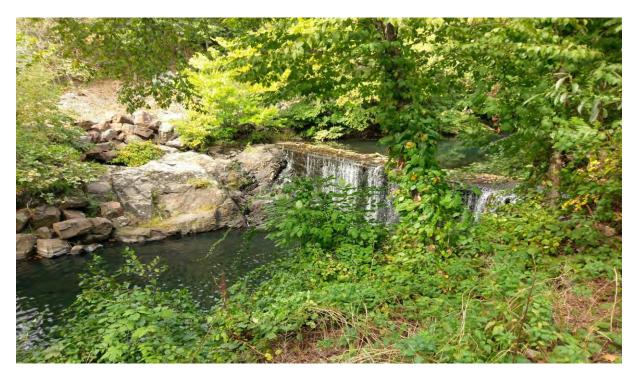
Water depth appeared highly variable throughout the channel, ranging from 2 to 3 feet deep in the center of the channel, to deeper pools in the vicinity of the dam. Additionally, substrate also varied, and was not visible in many areas. Boulder, rocks, and cobble were observed through most visible portions of the river as well as silt, leaf litter, and detritus.

PHOTO 11: View of dam in the Norwalk River, downstream of Route 15.

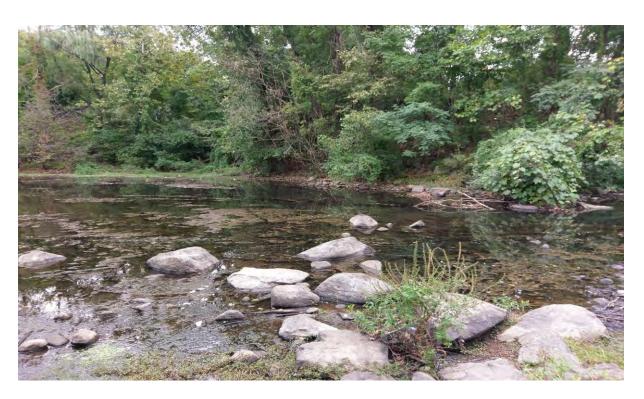
PHOTO 12: View of the Norwalk River from Wetland 5, looking northeast.

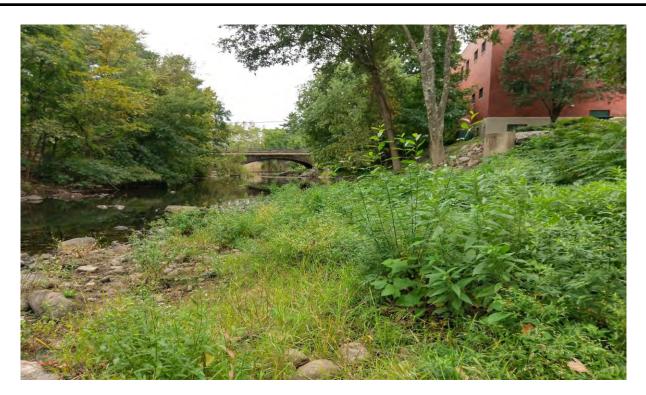
PHOTO 13: View Wetland 5, looking south towards the Glover Street bridge.

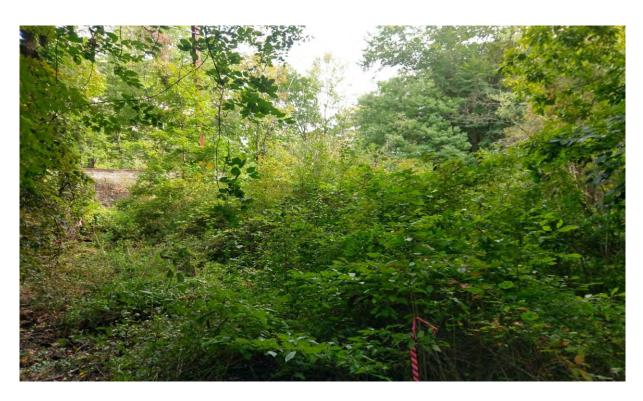
PHOTO 14: View of Wetland 6 looking southeast towards the railroad tracks.

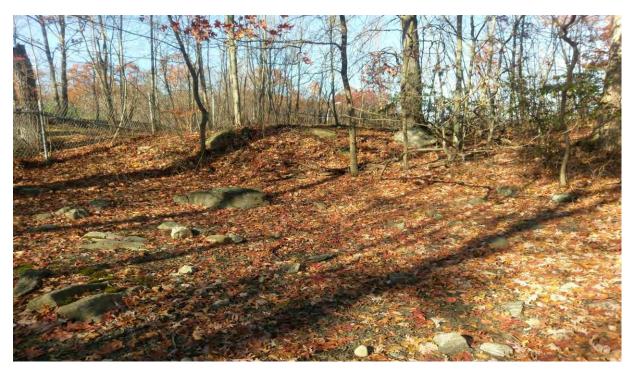
Wetland 7 is located west of the railroad tracks, east of Route 7, and south of the Route 15/Route 7 interchange. The palustrine scrub-shrub wetland is an isolated depression situated at the top of a rock outcrop and is characterized by inundation and saturation visible on aerial imagery, and water-stained leaves. Vegetation is lacking within the wetland; however, hydrophytes are present along the edges. A sparse tree stratum is dominated by pin oak (*Q. palustris*) along the wetland boundary. The scrub-shrub stratum is dominated by highbush blueberry (*Vaccinium corymbosum*), pin oak saplings, mountain laurel (*Kalmia latifolia*), and coastal sweet pepperbush (*Clethra alnifolia*).

The functions and values of Wetland 7 are extremely limited due to its small size and location on top of a rock outcrop. The only functions of the wetland appear to be floodflow retention and wildlife habitat. During storm events water from the surrounding upland gathers in the depression, ponds, and is slowly returned to the water table or evaporates. The wetland is located in a forested hilltop with a relatively sparse understory and is likely utilized by several small mammals and bird species as a water source. It should be noted that no ponding was observed during the September delineation nor during a November revisit. Observations of ponding are based on current and historical aerial imagery. Ponding may have been absent due to the moderate drought that was occurring during the time of the investigation.

PHOTO 15: View of Wetland 7 looking north towards the Route 15/7 interchange. Note lack of vegetation within the depression

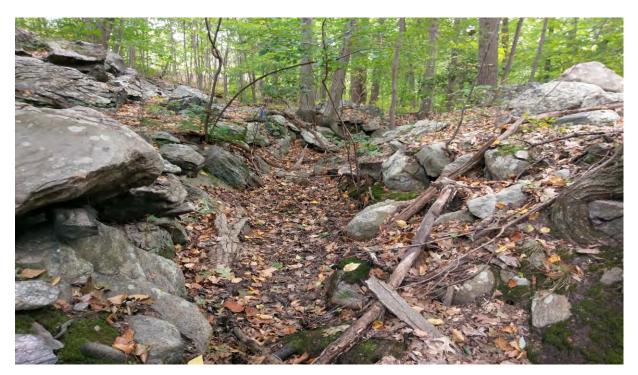
PHOTO 17: View of INT 2 looking southeast towards Wetland 8. Note boulders and rocks forming the banks.

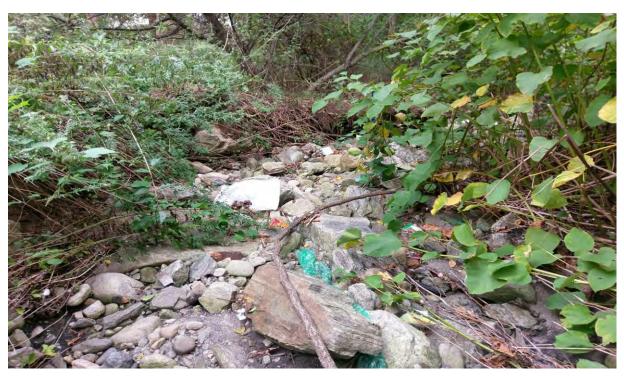
PHOTO 18: View of INT 3 at its upper reaches near Route 7 northbound. Note the substrate is cobble and rock; substrate changes to sand and gravel downstream.

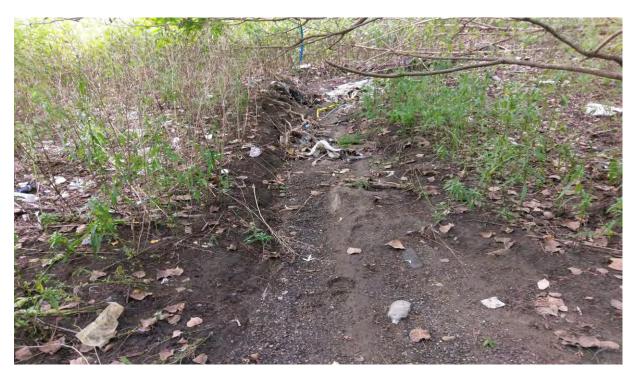
PHOTO 19: View of INT 4, looking west towards Route 7 northbound. Note refuse and sedimentation in the channel.

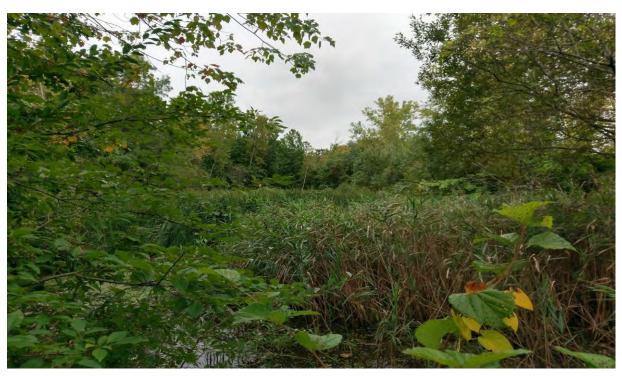
PHOTO 20: View of Wetland 9, looking northwest towards Route 7. Note common reed growing in and around inundated area.

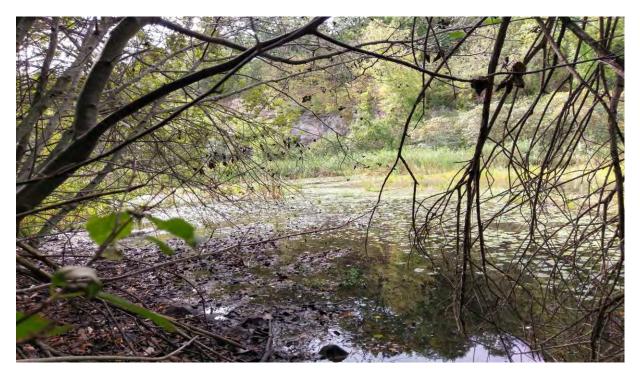
PHOTO 21: View of Wetland 10 looking southwest over the ponded area.

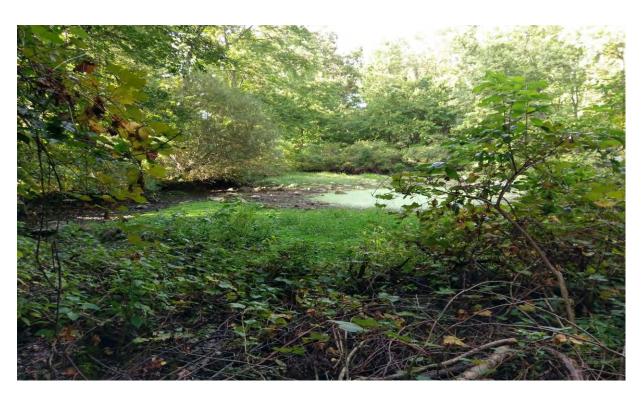
Wetland 11 is located west of the powerline ROW, north of Route 15, and east of Perry Avenue. USFWS NWI map classifies this feature as a Palustrine Aquatic Bed Permanently Flooded Excavated wetland (PABHx); field investigations found forested wetland surrounding the ponded area, and therefore classified the feature as a palustrine forested wetland. The wetland is characterized by inundation visible on aerial imagery, water-stained leaves, drainage patters, and geomorphic position. The ponded area also exhibited several other hydrologic indicators including several inches of standing water and an algal mat. Wetland 11 is bisected by an impervious access road, a 12" RCP pipe connects both sides of the wetland under the access road. The wetland also connects to Wetland 12 to the south via Intermittent Watercourse 5.

PHOTO 22: View of Wetland 11 looking north, note ponded area in the center void of vegetation surrounded by forested wetland.

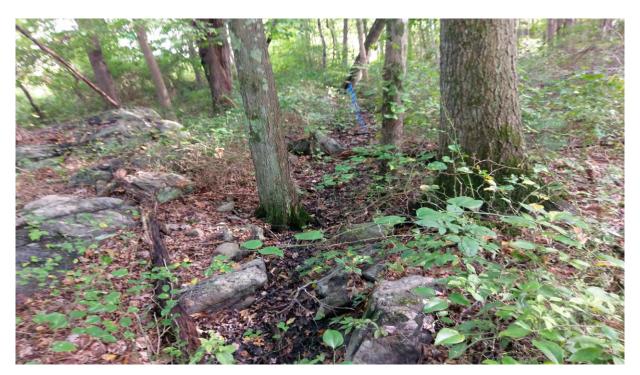
Intermittent Watercourse 5 is located north of Route 15, west of the powerline ROW and east of Perry Avenue. The watercourse hydraulically connects Wetlands 11 and 12. This intermittent watercourse is approximately 3 feet wide with a silt and leaf litter substrate. Drift deposits and water-stained leaves were also noted in the channel. The watercourse receives flows from the surrounding uplands and wetlands, and conveys flows during

PHOTO 23: View of INT 5 which connects Wetland 11 and 12, looking south towards Wetland 12.

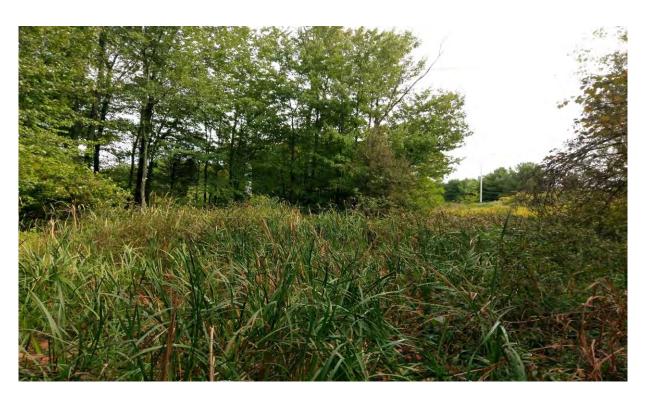
Wetland 12 is located east of Perry Avenue, north of the Route 15 southbound entrance ramp, and the western limit is partially within the powerline ROW. The wetland is situated at the base of a steep roadway embankment and extends into the powerline ROW. Intermittent Watercourse 5 connects Wetland 12 to Wetland 11 to the north. The palustrine emergent wetland is characterized by water-stained leaves and geomorphic position, and receives drainage from a 15" CMP that discharges to the northern embankment of the Route 15 southbound on-ramp. When water levels are high, water flows west out of the wetland and into a catch basin which ultimately discharges to Intermittent Watercourse 8, hydraulically connecting Wetland 12 with Wetlands 14 and likely 15. Red maple (A. rubrum) and black willow (Salix nigra) dominate the sparse tree canopy; green ash (F. pennsylvanica) is also present but not dominant. Button-bush (Cephalanthus occidentalis) and panicle hydrangea (H. paniculata) dominate the sparse scrub-shrub stratum; highbush blueberry (*V. corymbosum*) is present but not dominant. The herbaceous stratum is very diverse and dominated by narrow-leaf cattail (Typha angustifolia), harlequin blueflag (Iris versicolor), Virginia Marsh St. Johnswort (Hypericum virginicum), and false nettle (B. cylindrica). Rough bedstraw (Galium asprellum), marsh fern (T. palustris), arrow-leaf teathumb (P. sagittata), smooth beggartick (Bidens laevis), fowl manna grass (G. striata), and soft rush (J. effusus) were also present but not dominant. No woody vine stratum was noted.

PHOTO 24: View of Wetland 12 looking east towards the powerline ROW.

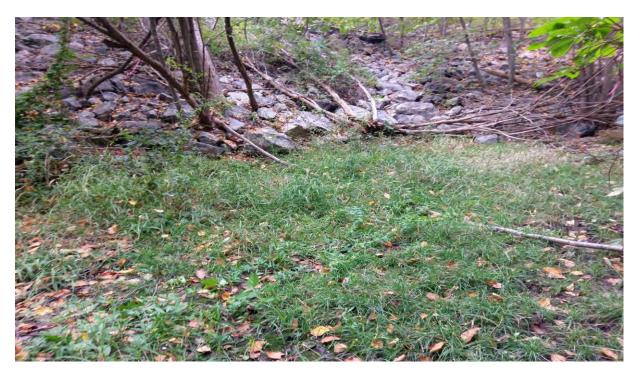
PHOTO 25: View of emergent portion of Wetland 13 looking northeast towards embankment.

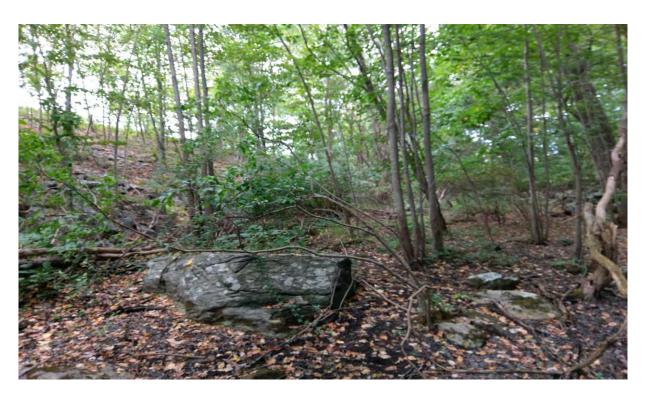
PHOTO 26: View of forested portion of Wetland 13 looking east, note large boulders and lack of herbaceous growth.

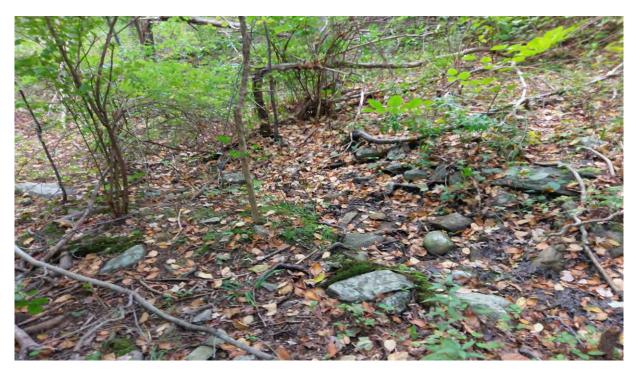
PHOTO 27: Downstream view of INT 6 looking west towards Wetland 13.

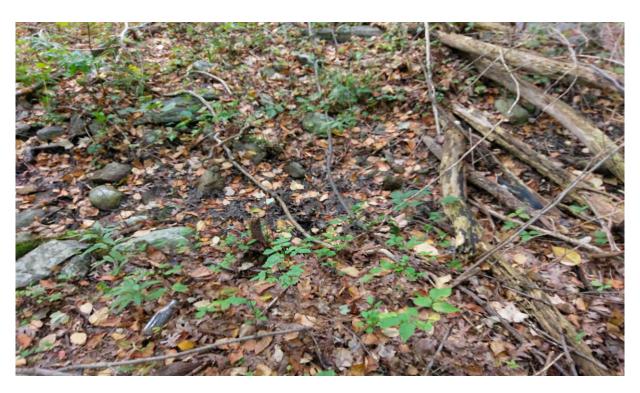
PHOTO 28: View of OHWM of INT 7 looking north.

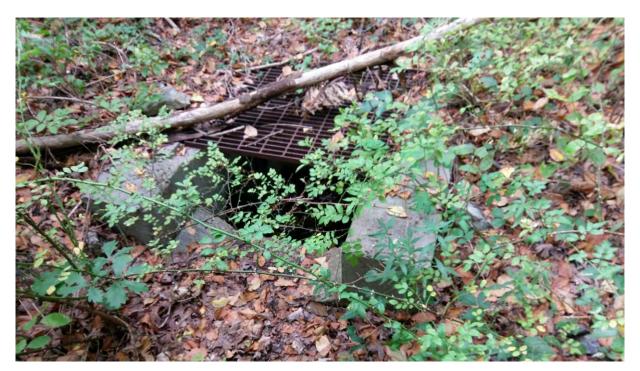
PHOTO 29: View of catch basin downstream of INT 7.

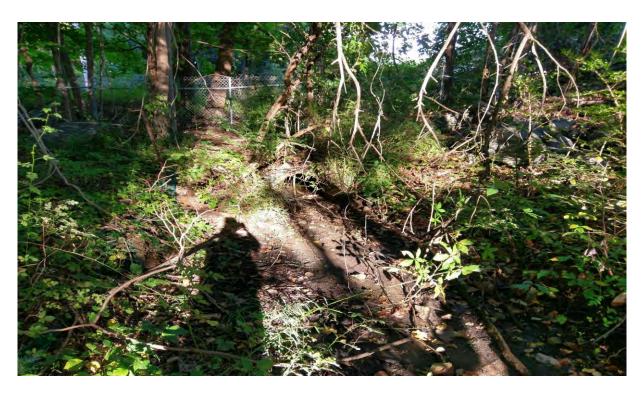
Intermittent Watercourse 8 begins at a 30" RCP drainage outfall west of Perry Avenue, which is partially buried by sediment. During high water levels, the watercourse also receives hydrology from Wetland 12 via a catch basin located immediately west of Wetland 12. The channel varies in width but is approximately 3 feet wide on average with a silt and cobble substrate. Sedimentation was noted within the channel and the pipe outfall. The southern bank that runs parallel to the Route 15 embankment is undercut and eroded in some areas exposing roots. The banks of the watercourse are densely vegetated with herbs including poison ivy (T. radicans) and shrubs including silky dogwood (C. amomum). Intermittent Watercourse 8 meanders through the forest understory and becomes braided, eventually diverging to form a second channel, Intermittent Watercourse 9, which flows offsite to the northwest. Intermittent Watercourse 8 continues to flow west into the vicinity of Wetland 14 before flowing offsite to the northwest. Intermittent Watercourse 9 is very similar in character to Intermittent Watercourse 8, but narrows to approximately 1.5-feet wide. Drift deposits in the form of small branches and woody debris were noted in the channel. A larger wetland system that appears to be connected to Wetland 14 is present off-site to the north, therefore Intermittent Watercourses 8 and 9 appear to contribute to its hydrology.

PHOTO 30: View of INT 8, looking east towards Perry Avenue, note culvert is partially buried.

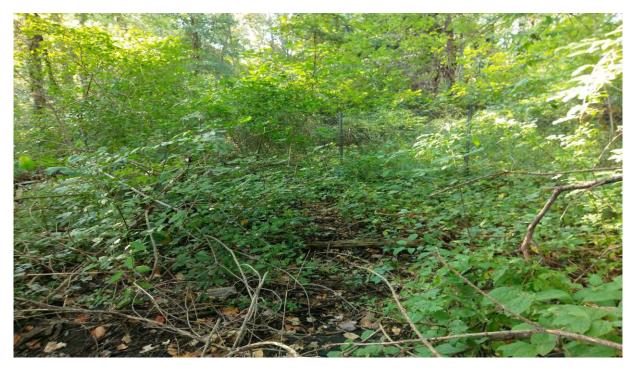
PHOTO 31: View of INT 9 flowing northwest off-site; banks are densely vegetated with herbs and shrubs.

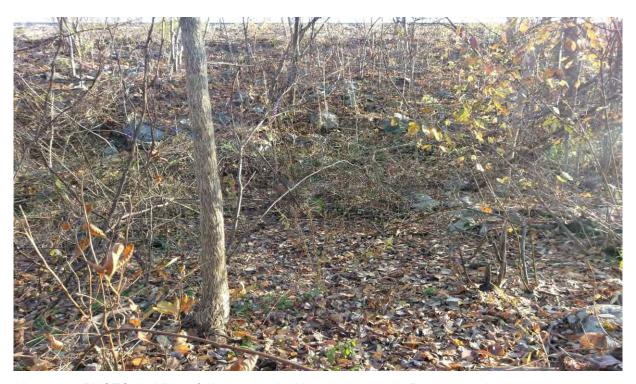
Wetland 14 is located west of Perry Road and north of Route 15 near the western project limits. The forested wetland appears to extend off-site to the north, where it likely receives hydraulic input from Intermittent Watercourses 8 and 9; it is also likely that Wetland 14 and 15 are hydraulically connected off-site to the north. Wetland 14 is characterized by water-stained leaves, drainage patterns, and geomorphic position. The tree canopy is dominated by red maple (*A. rubrum*) and American elm (*U. americana*). A dense shrub understory is dominated by spicebush (*L. benzoin*) and silky dogwood (*C. amomum*). Additional non-dominant shrubs include coastal sweet pepperbush (*C. alnifolia*) and multiflora rose (*R. multiflora*). Poison ivy (*T. radicans*) dominates the herbaceous stratum; bristly dewberry (*Rubus hispidus*) rough-leaf goldenrod (*S. rugosa*), American elm seedlings, and sensitive fern (*O. sensibilis*) were also present but not dominant herbs observed in the wetland. Fox grape (*V. labrusca*) and poison ivy dominate the woody vine stratum.

PHOTO 32: View of Wetland 14 looking south towards Route 15 embankment.

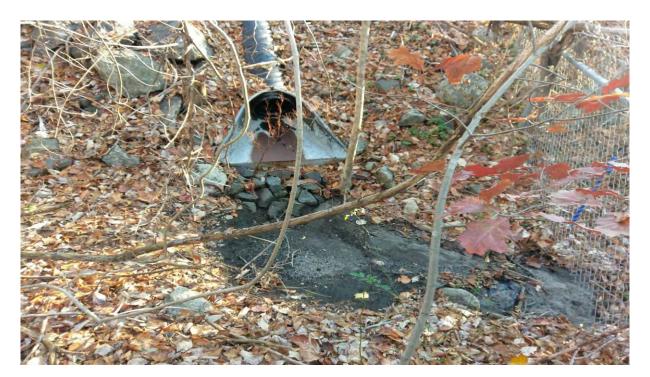
Intermittent Watercourse 10 originates from an 18" RCP pipe outfall at the base of the Route 15 embankment that appears to carry drainage from the highway. A small riprap splash pad is located at the base of the outfall. The channel is approximately 4 feet wide with a silt and leaf litter bottom, with heavy sedimentation. Water-stained leaves and woody debris were also noted in the channel. The watercourse is situated in a forested area, however trees in the vicinity of the channel have recently been cleared. Some vegetation, namely multiflora rose (*R. multiflora*), oriental bittersweet (*C. orbiculatus*), and greenbrier (*S. rotundifolia*), hang over portions of the channel. The watercourse flows west, eventually flowing into Wetland 15 where the channel loses definition and transitions to sheet flow.

PHOTO 33: View of INT 10 pipe outfall, looking south towards Route 15 embankment.

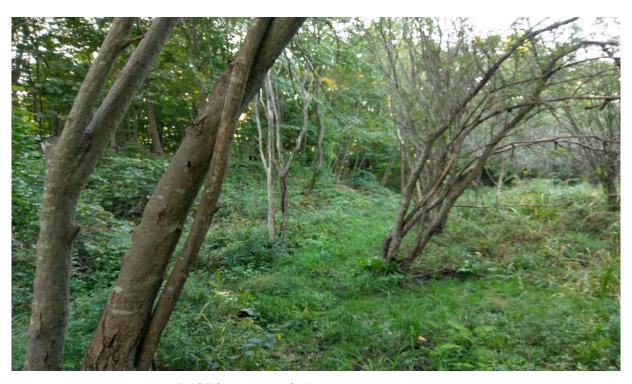
Wetland 15 is located at the western limit of the project, north of Route 15 and west of Wetland 14. The palustrine scrub-shrub wetland extends off-site to the north; it is also likely that Wetland 15 and 14 are hydraulically connected off-site to the north. Wetland 15 is characterized by high water table and saturation 8 inches below the surface, water-stained leaves, and geomorphic position. The wetland receives flows from Intermittent Watercourse 10 as well as a 15" RCP outfall along the northern embankment of the Route 15 southbound on-ramp that appears to carry drainage from the roadwat. Pussy willow (Salix discolor) dominates an extremely sparse tree stratum. Pussy willow also dominates the shrub stratum in addition to multiflora rose (R. multiflora). Wineberry (R. phoenicolasius) is present in the shrub stratum, but not dominant. Arrow-leaf tearthumb (P. sagittata), calico aster (S. lateriflorum), rough-leaf goldenrod (S. rugosa), and Japanese knotweed (Polygonum cuspidatum) dominate the herbaceous stratum. Marsh fern (T. palustris), poison ivy (T. radicans), sensitive fern (O. sensibilis), broad-leaf cattail (T. latifolia), curly dock (Rumex crispus), and prickly sedge (Carex stipata) are also

PHOTO 34: View of Wetland 15 looking north.

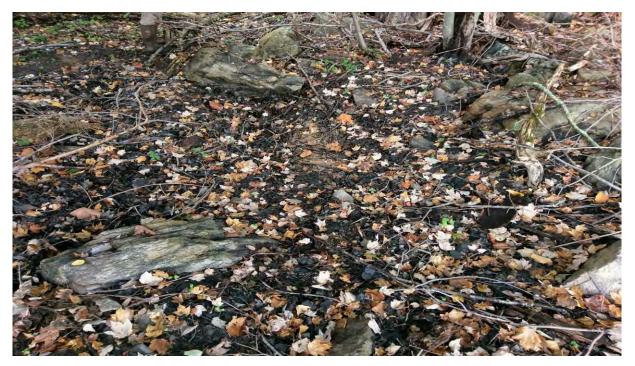
The first location, Sample Point 1 "SP-1", is situated west of Route 7 and north of Route 15, between Wetland 10 and 12. The site was a small depression characterized by a sparsely vegetated concave surface with water-stained leaves, red maple (*A. rubrum*) in the tree canopy and very sparse scrub-shrub stratum. Oriental bittersweet (*C. orbiculatus*) was also dominant in the woody vine stratum. No herbaceous stratum was observed. Despite the presence of hydrologic indicators and hydrophytic vegetation, the soil was bright and fairly well-drained with no redoximorphic features, therefore it failed to meet any hydric soil indicators, and also did not qualify as state wetland.

PHOTO 35: View of SP-1, a previously delineated wetland that failed to meet the definition of a wetland at the federal or state level due to lack of hydric or poorly-drained soils.

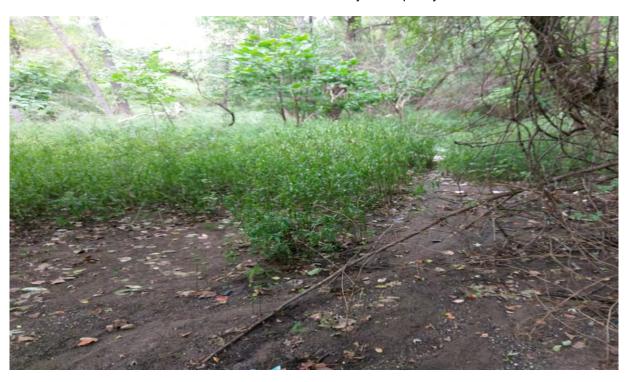
PHOTO 36: View of SP-2 looking south from INT 3.

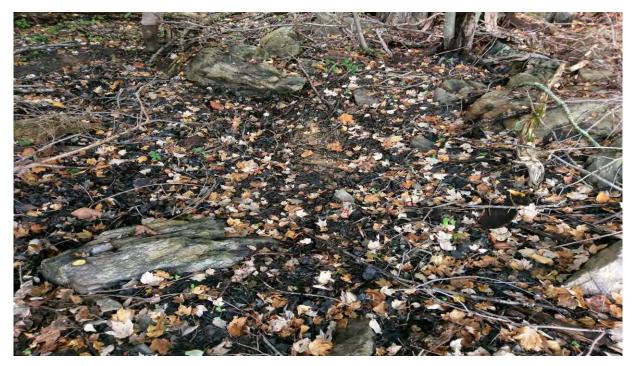
PHOTO 37: View of SP-1, a previously delineated wetland that failed to meet the definition of a wetland at the federal or state level due to lack of hydric or poorly-drained soils.

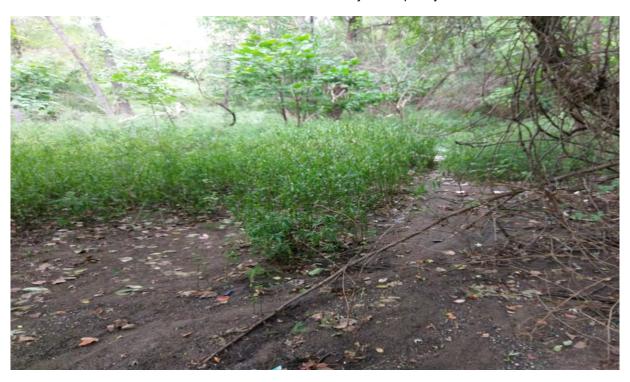
PHOTO 38: View of SP-2 looking south from INT 3.

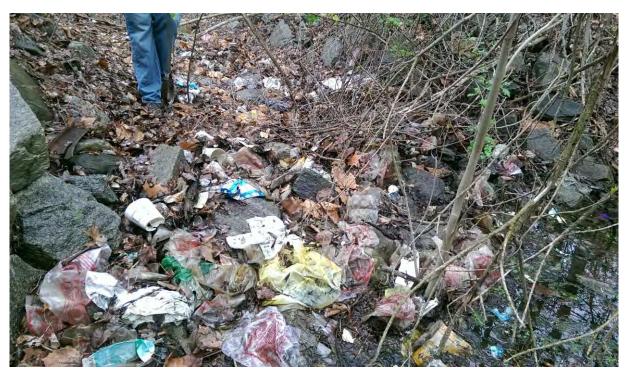
PHOTO 40: View of riprap lined swale looking southwest from stormwater basin. Note excessive refuse.

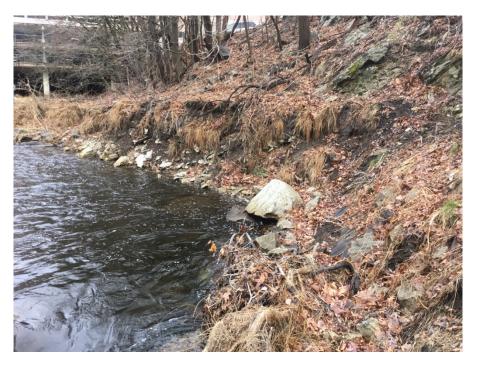
Photo 5. Former location of southern segment of Wetland 3 that has been since replaced by the revised Norwalk River channel, view to the north. Stantec. March 25, 2021.

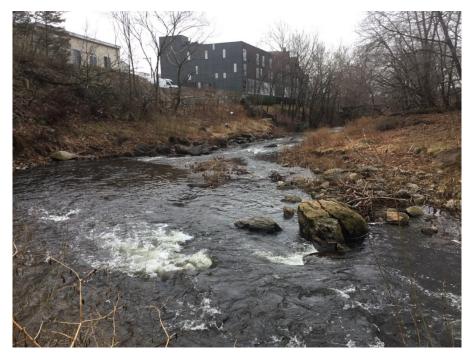
Photo 6. View to the south towards the former location of the Flock Process Dam on the Norwalk River. Stantec. March 25, 2021.
